Assessment of Dam Safety

Coal Combustion Surface Impoundments (Task 3)

Northern States
Power Company

Sherburne County
Power Station

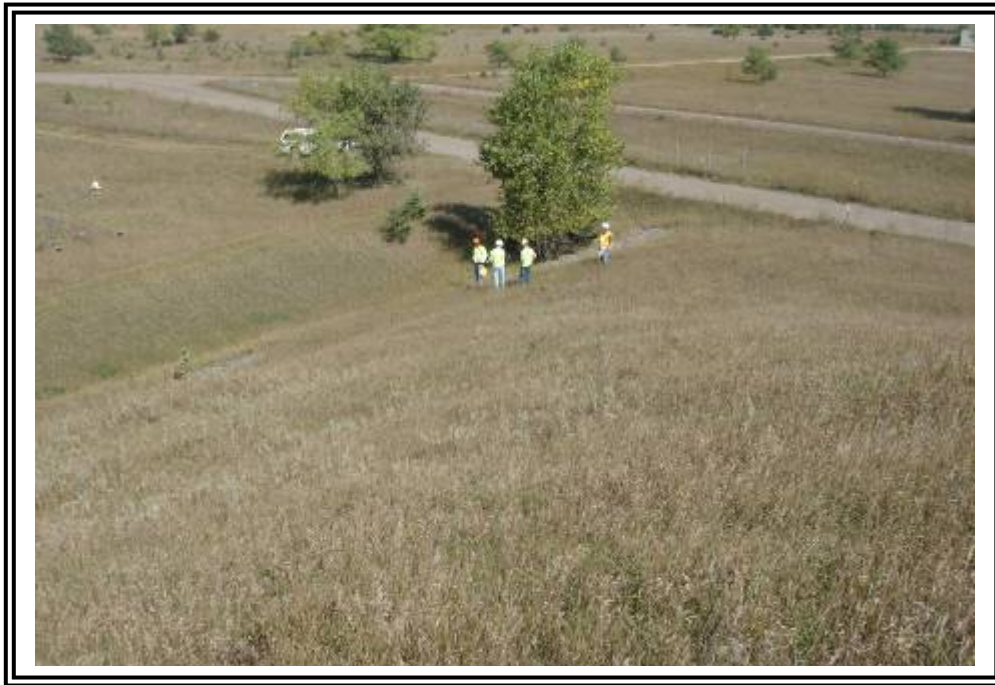
1

Intersection of downstream embankment slopes of North and East Dams, looking northwest.

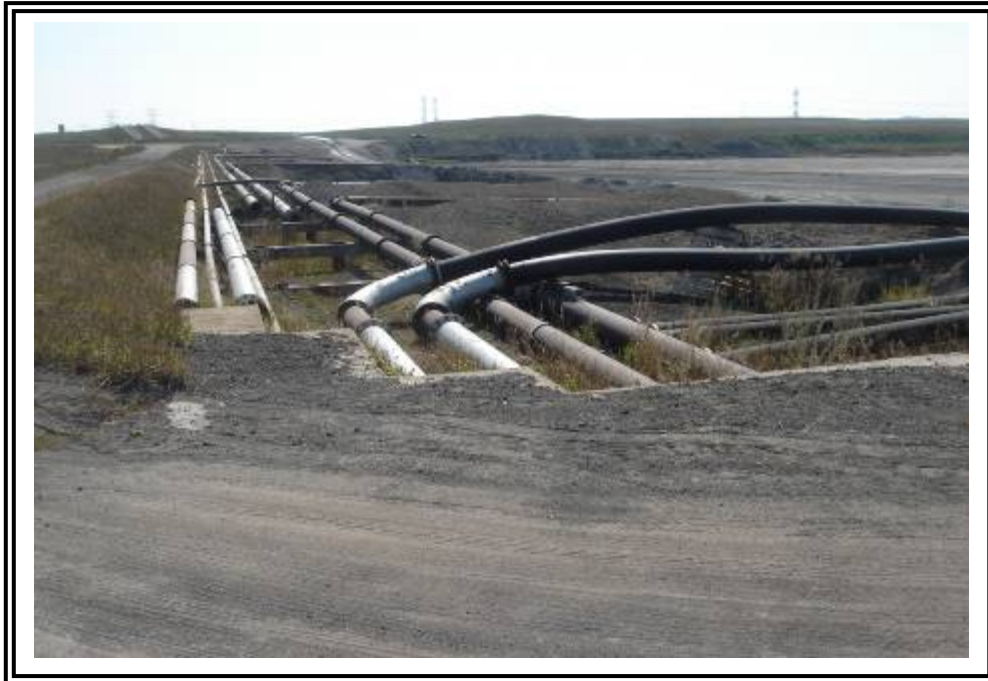
3

Upstream embankment slope of East Dam, looking south.

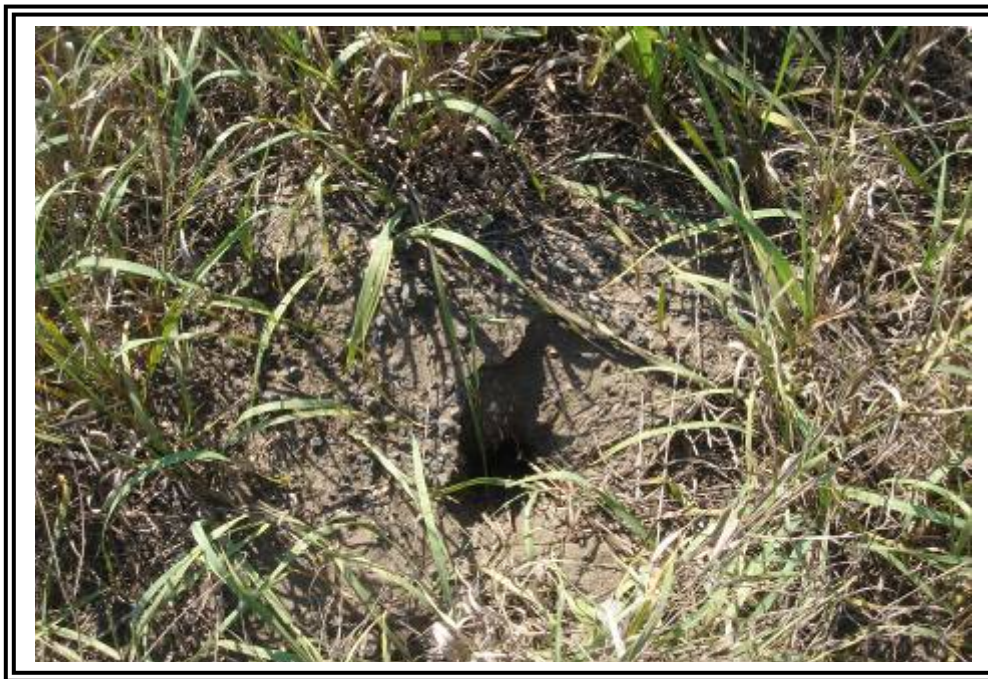
4

Animal burrows were observed along the faces and groins of the North and East Dams (Photo 4). One burrow was measured to be 24 inches deep at the groin of the East Dam (Photo 8).

Animal burrow in East Dam.

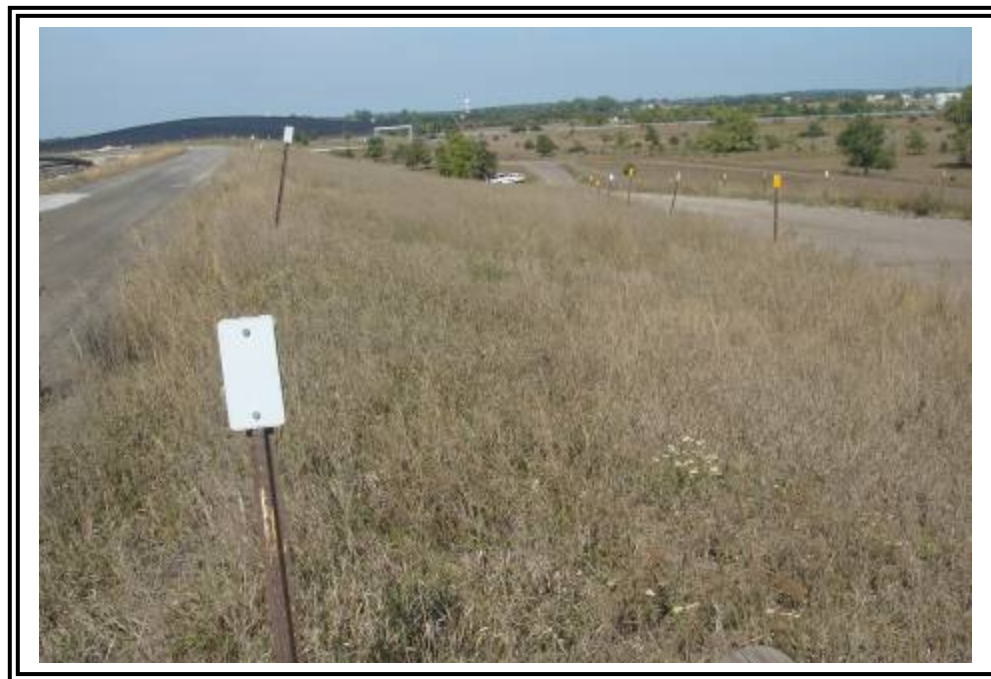
6

Downstream embankment slope of East Dam, facing north.

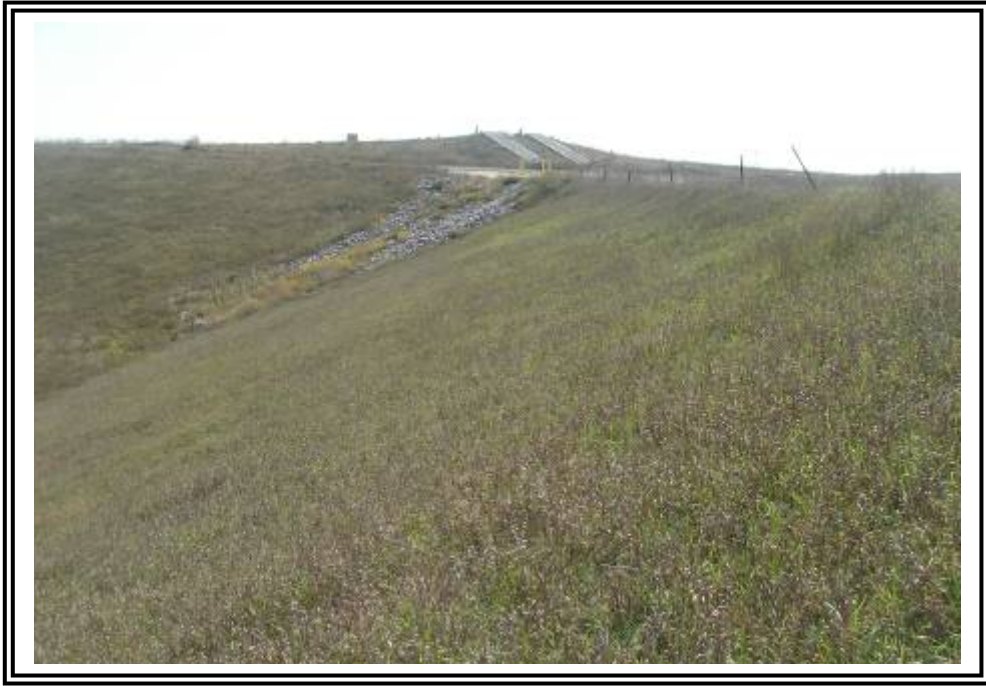
7

Downstream embankment slope of East Dam at south end of slope (groin), looking southeast.

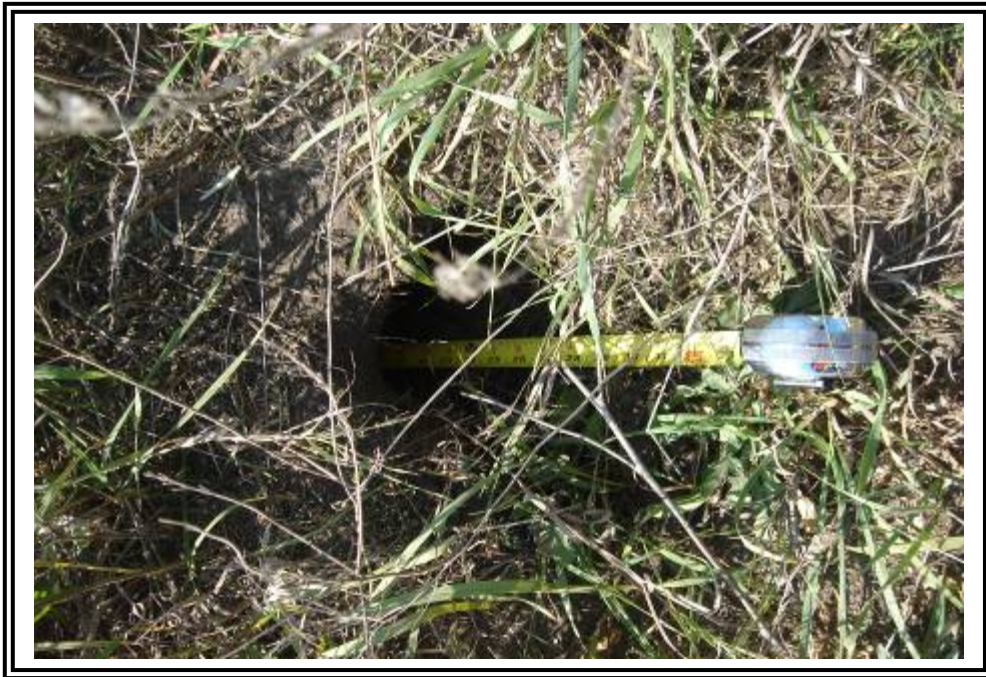
8

Animal burrow in East Dam near groin. Burrow was measured to be approximately 2'-4" deep from the ground surface.

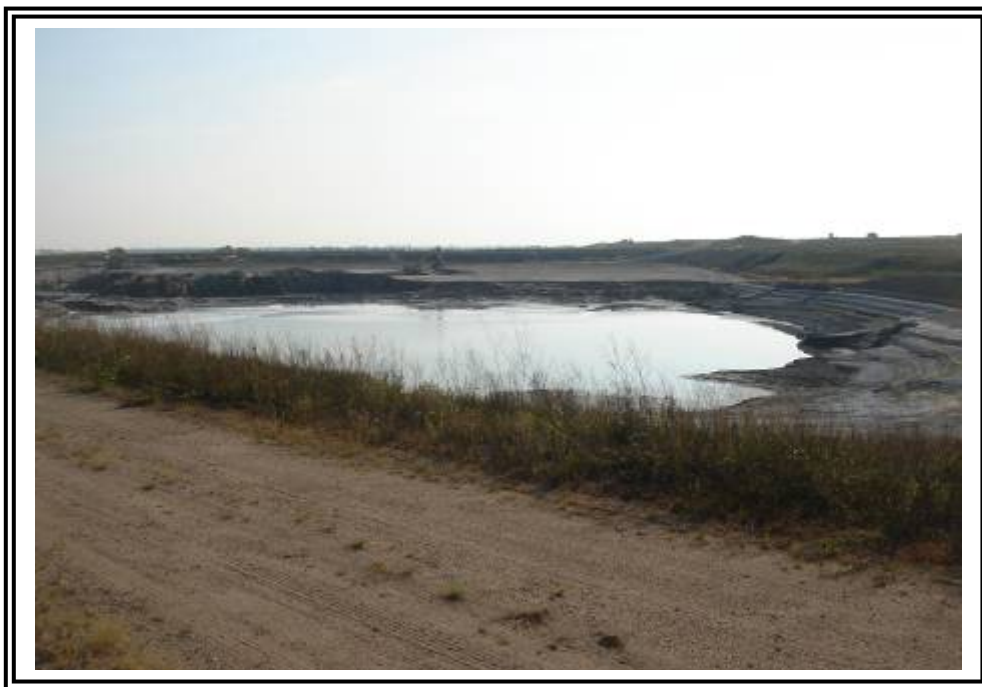
9

Looking across Bottom Ash Pond from the West Dam.

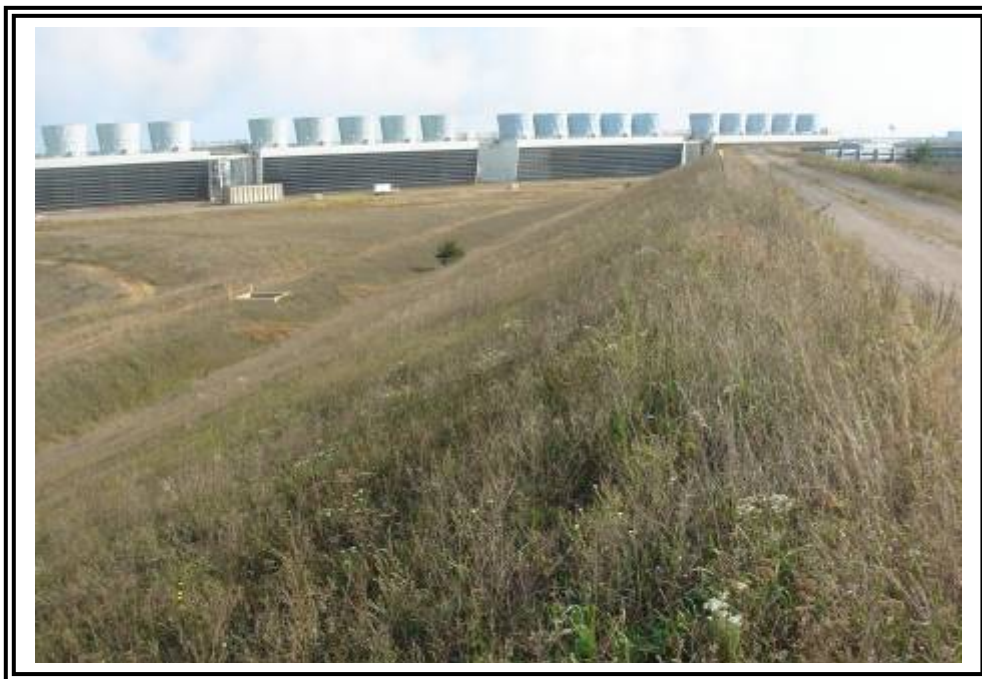
10

Downstream embankment slope West Dam, facing northeast.

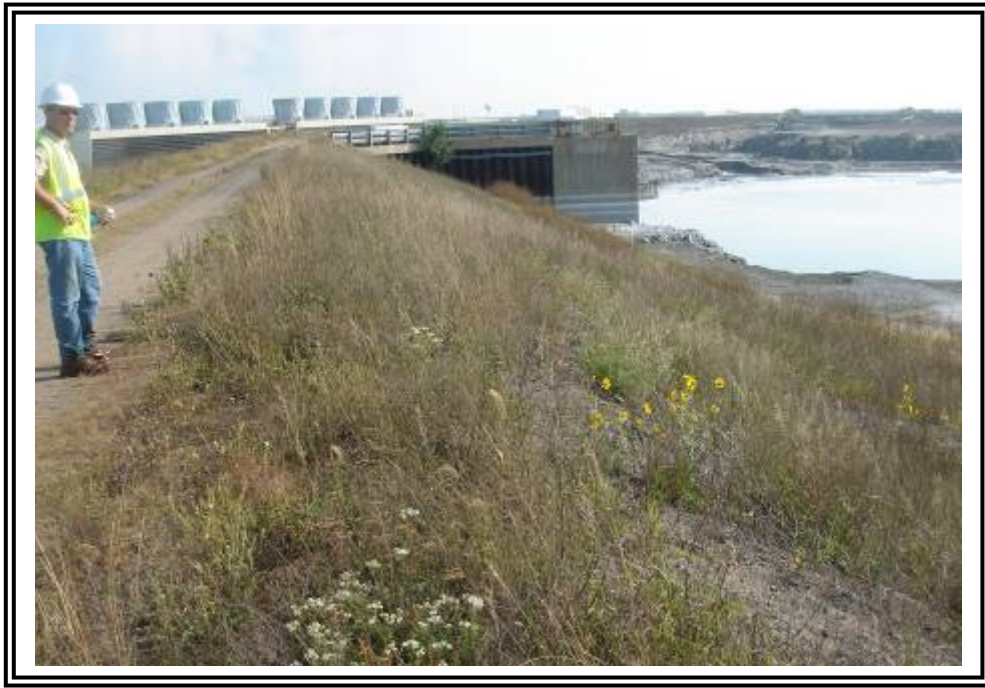
11

Upstream embankment slope of West Dam, facing northeast.

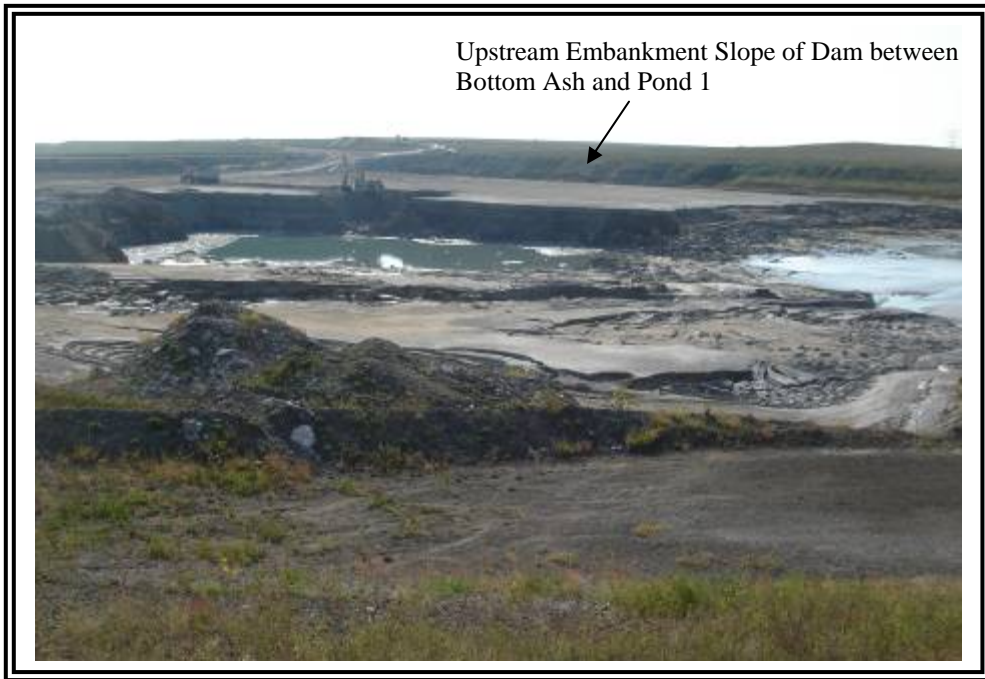
12

Looking across Bottom Ash Pond at upstream embankment slope of Dam between Bottom Ash Pond and Pond 1.

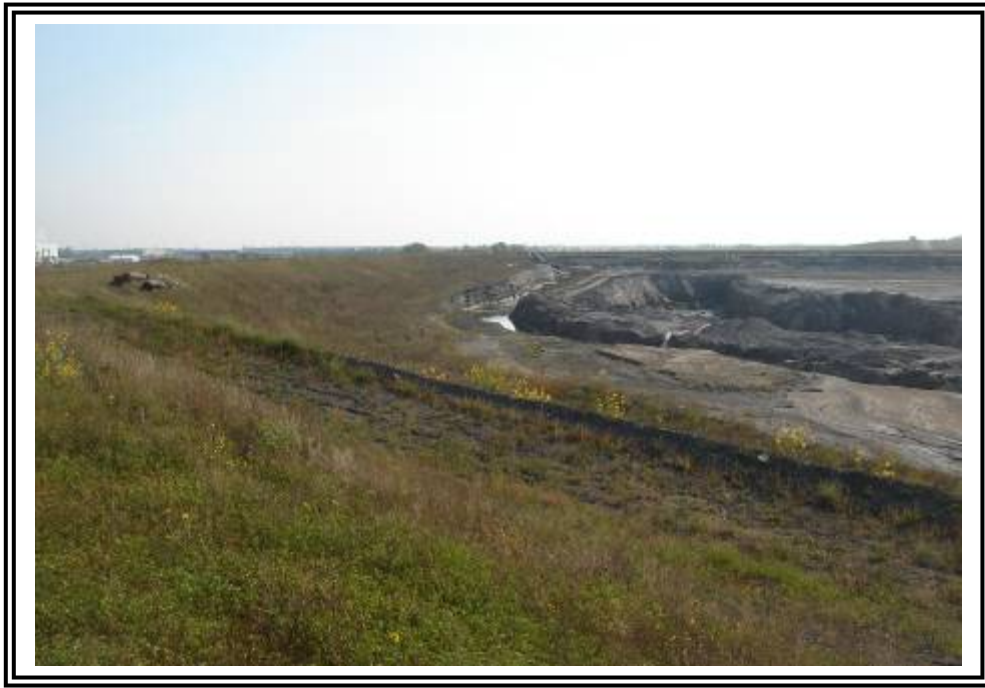
13

Upstream embankment slope of North Dam, facing east at corner of West and North Dams.

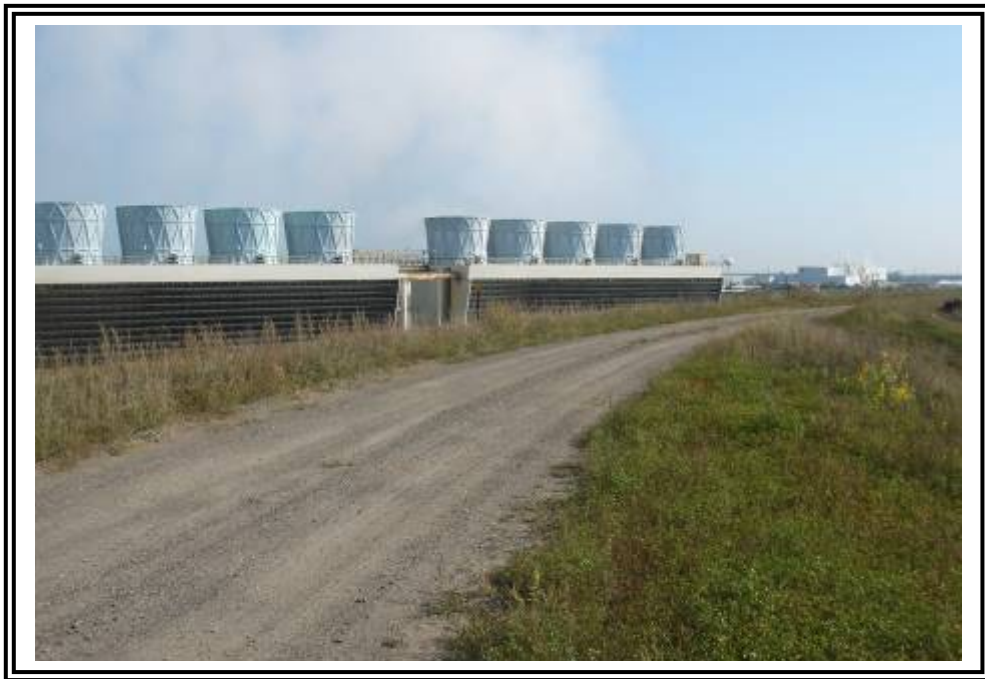
14

Crest of North Dam, facing east.

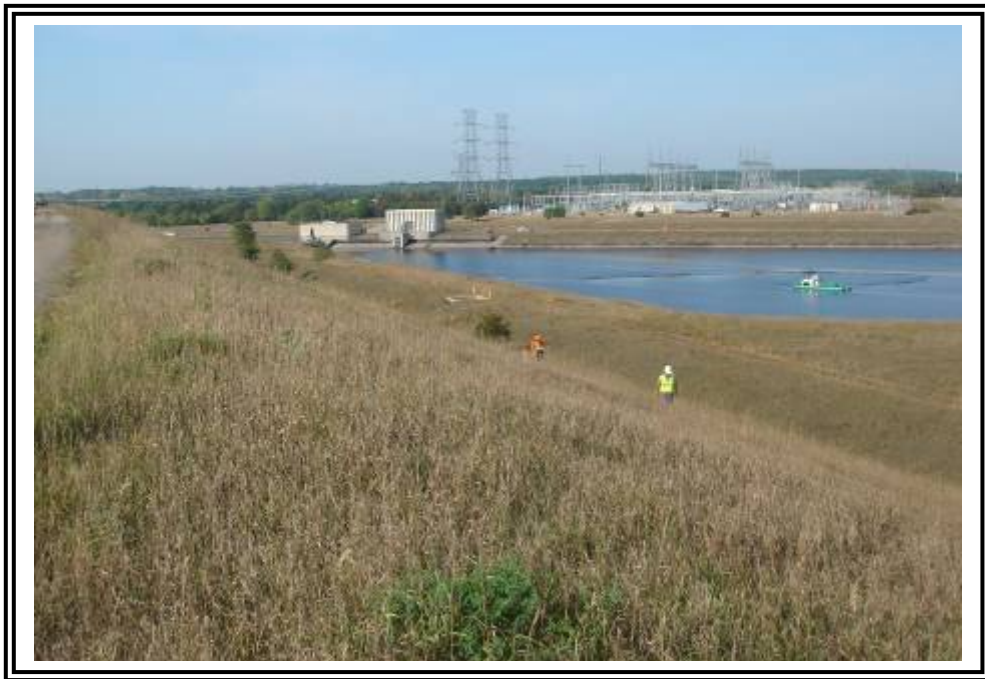
16

Downstream embankment slope of West Dam, facing northwest.

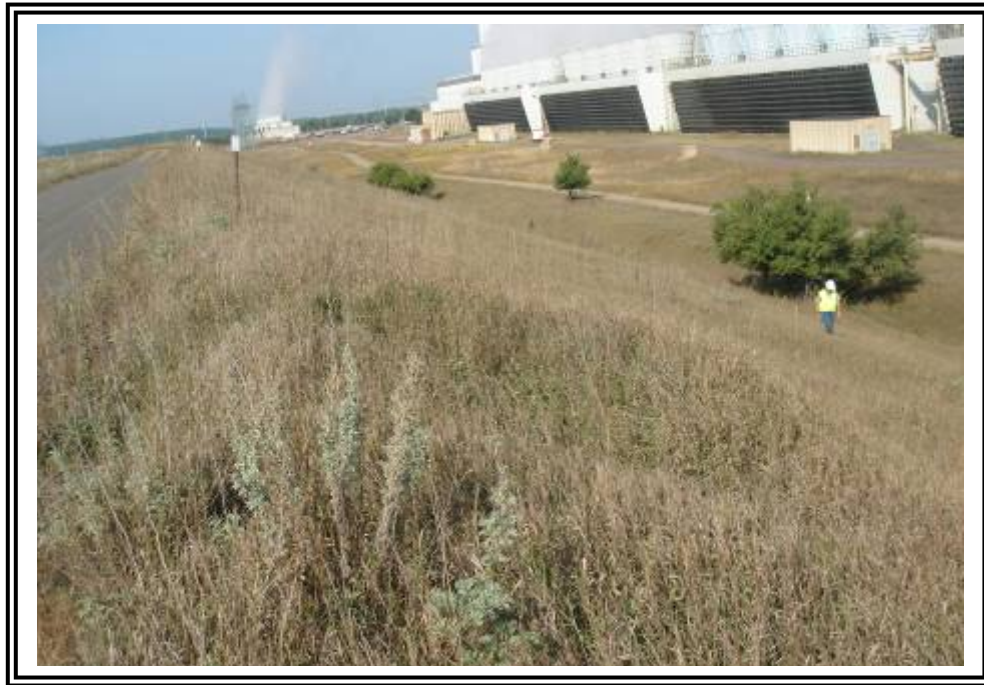
17

Downstream embankment slope and crest of North Dam, facing northwest.

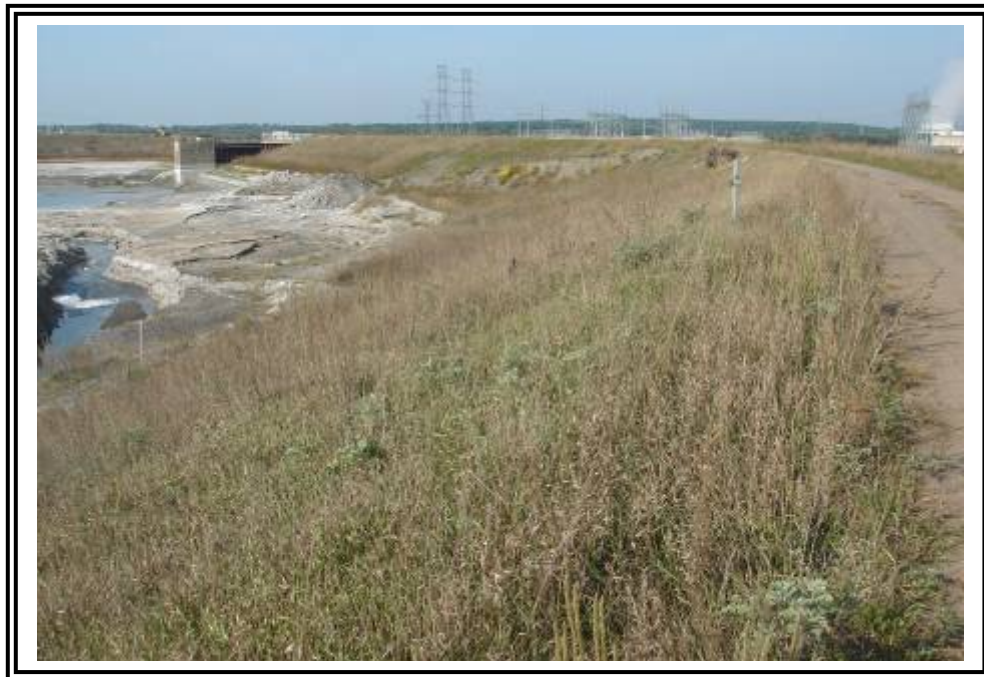
18

Upstream embankment slope of North Dam, facing west.

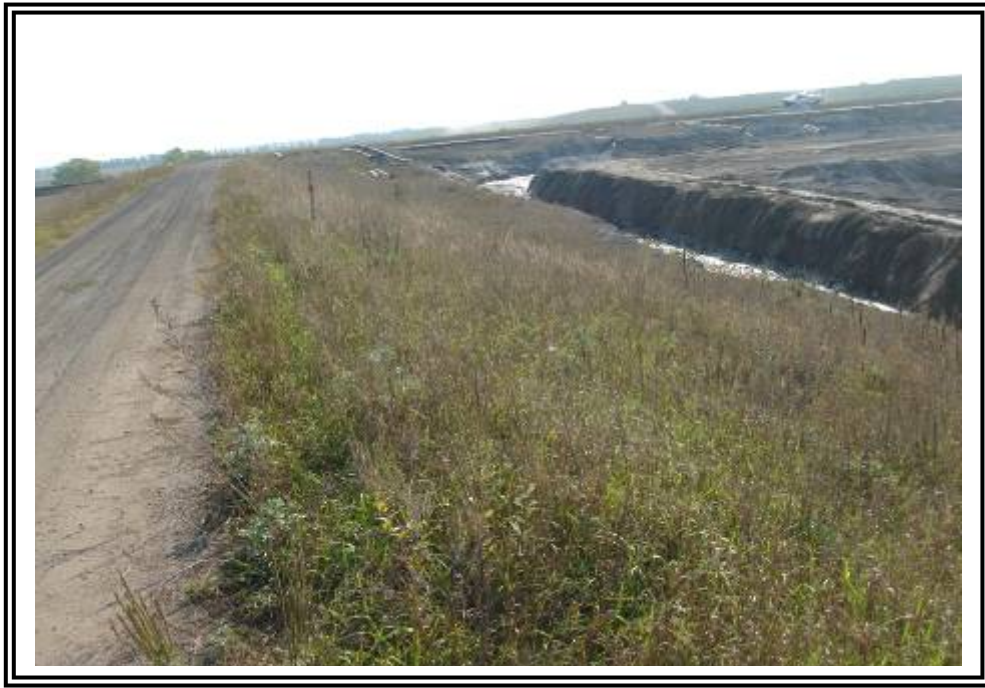
19

Upstream embankment slope and crest of North Dam, facing east.

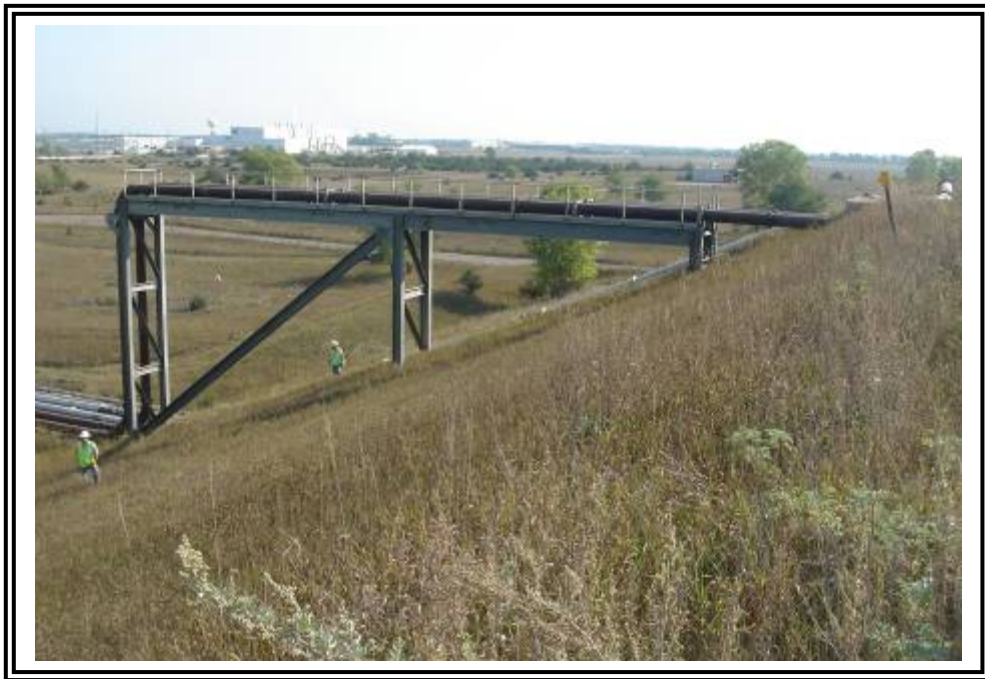
20

Downstream embankment slope of North Dam, facing east at corner of North and East Dams.

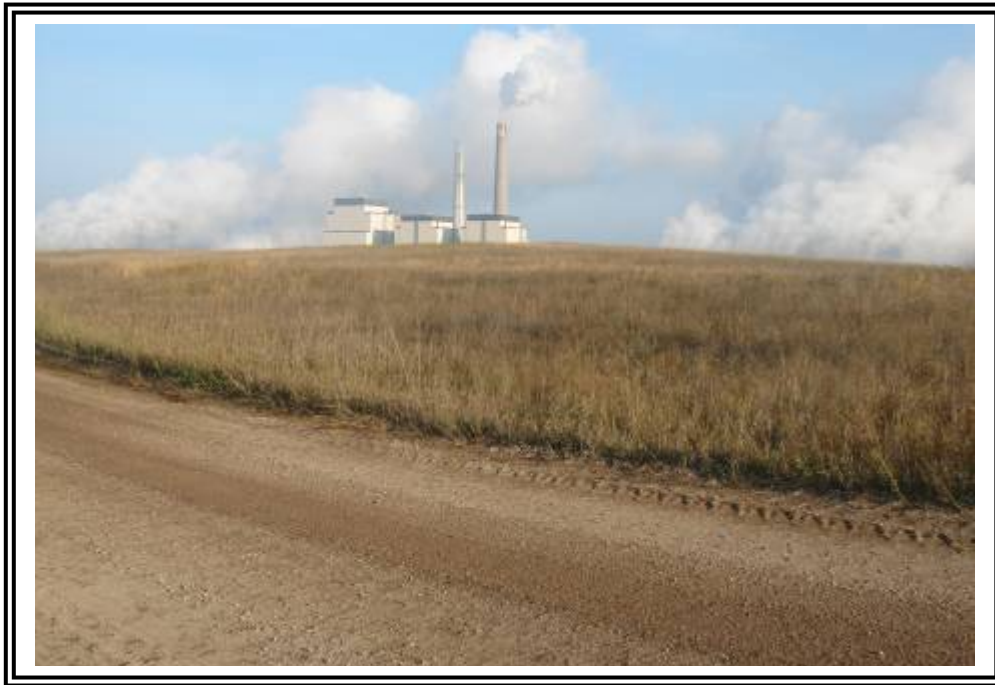
21

View across Pond 1 cap, facing northwest from South Dam.

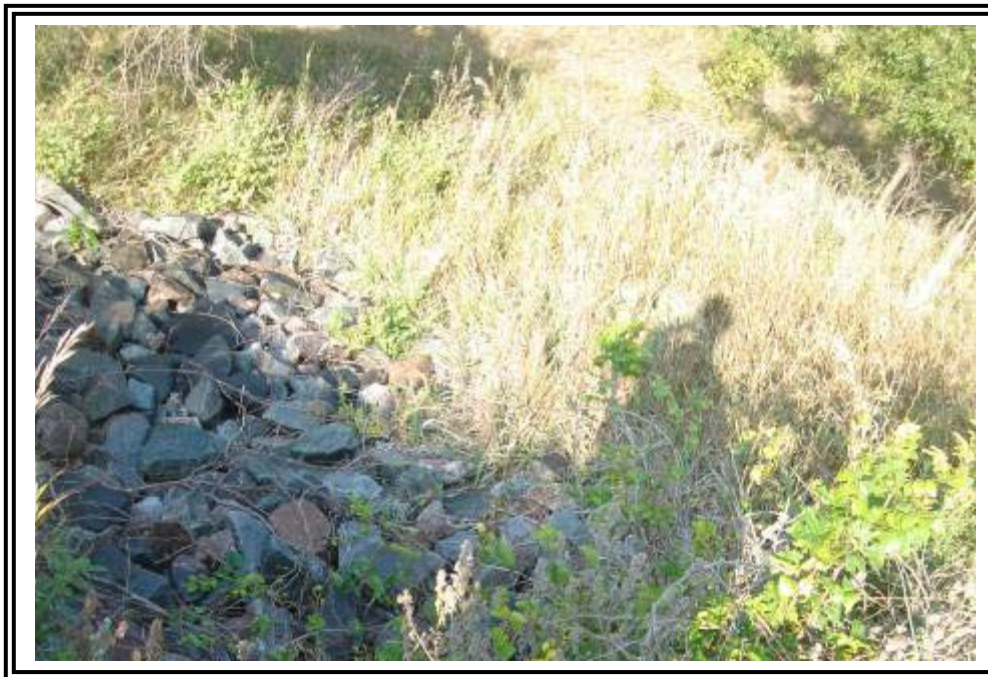
25

Drainage along downstream embankment slope of South Dam.

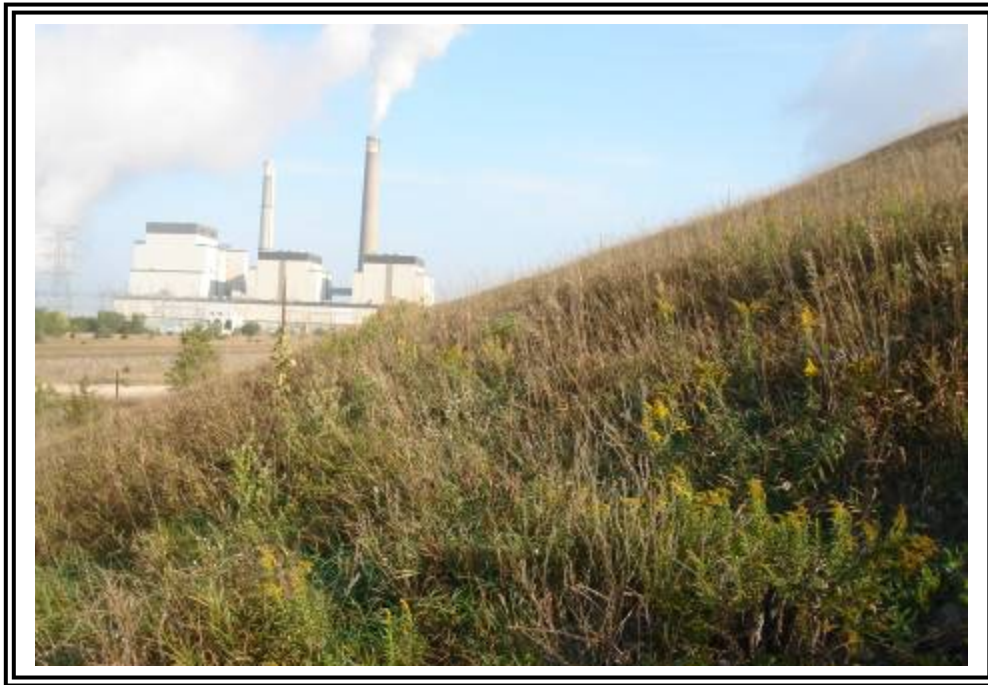
26

Downstream embankment slope of West Dam, facing north.

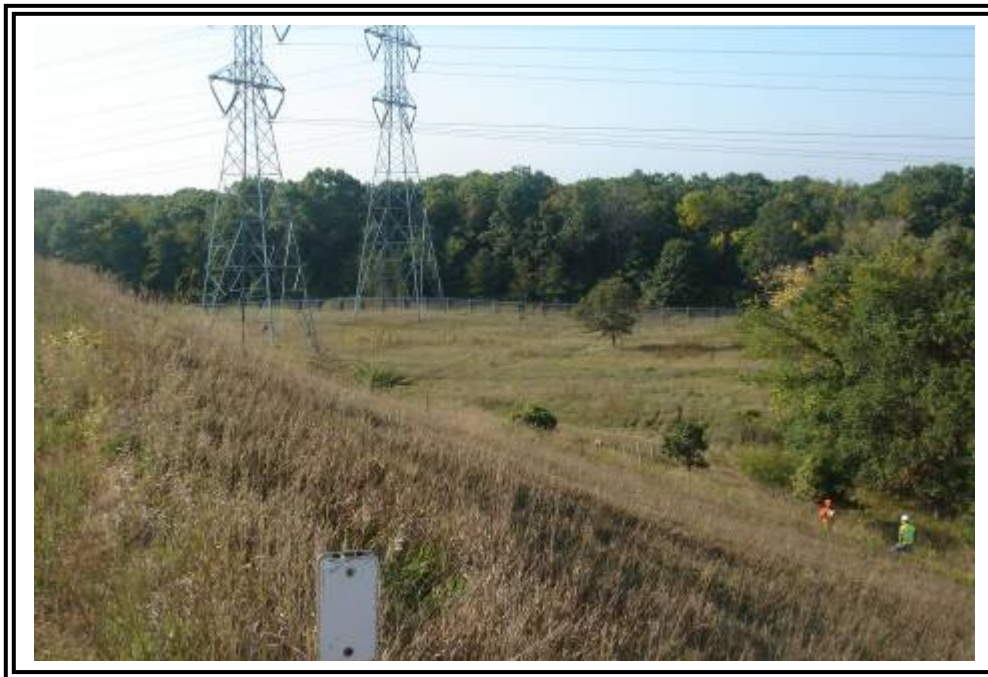
27

Downstream embankment slope of West Dam, facing south.

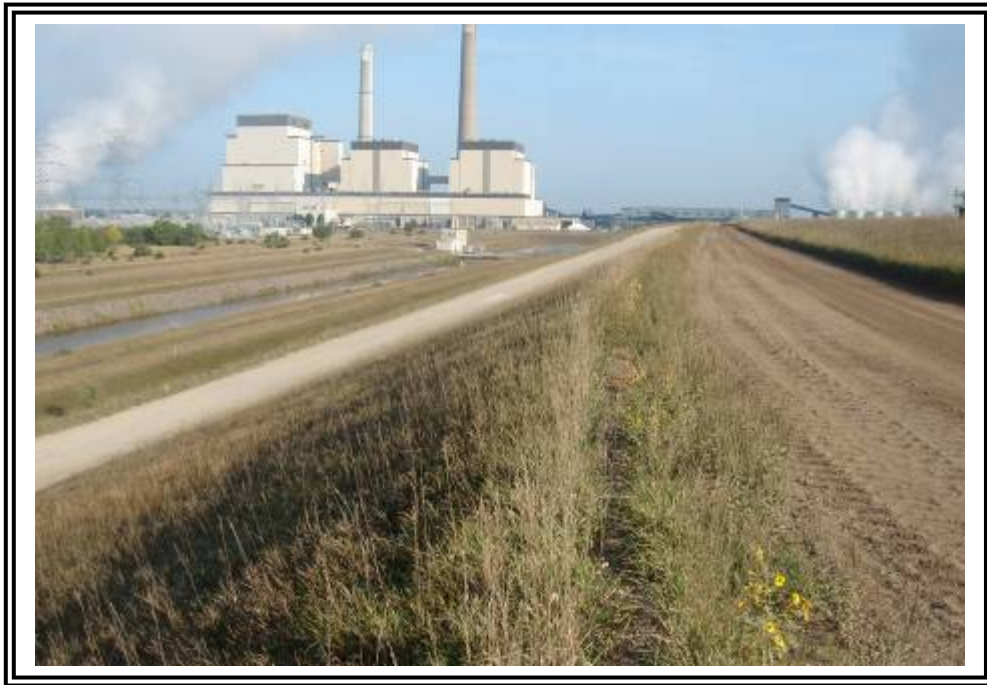
28

Downstream embankment slope and crest of West Dam.

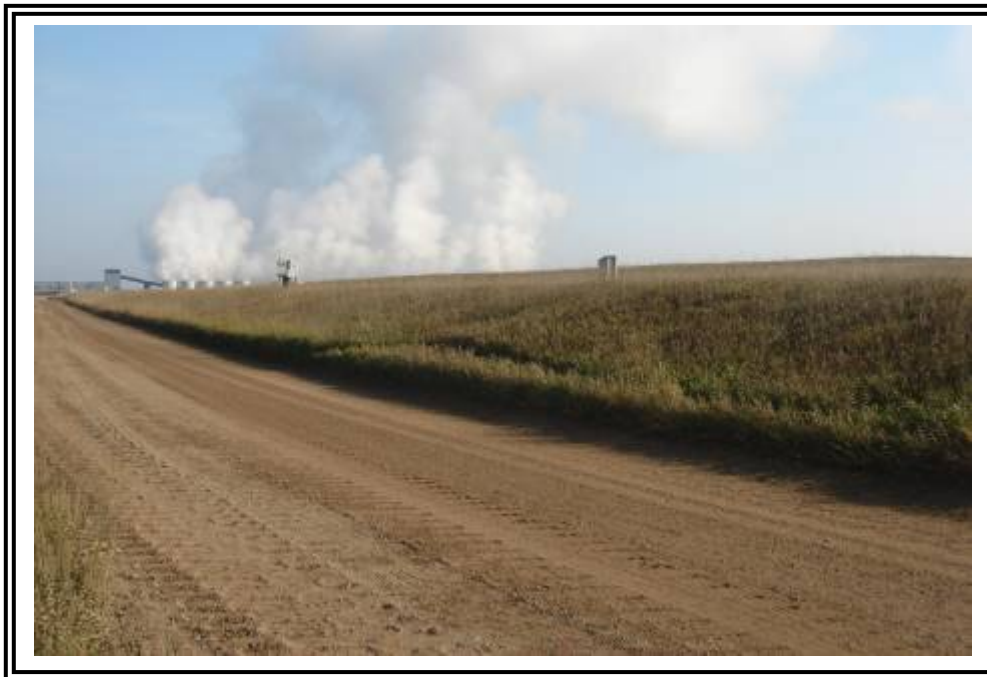
29

View across Pond 1 cap from West Dam, facing northeast.

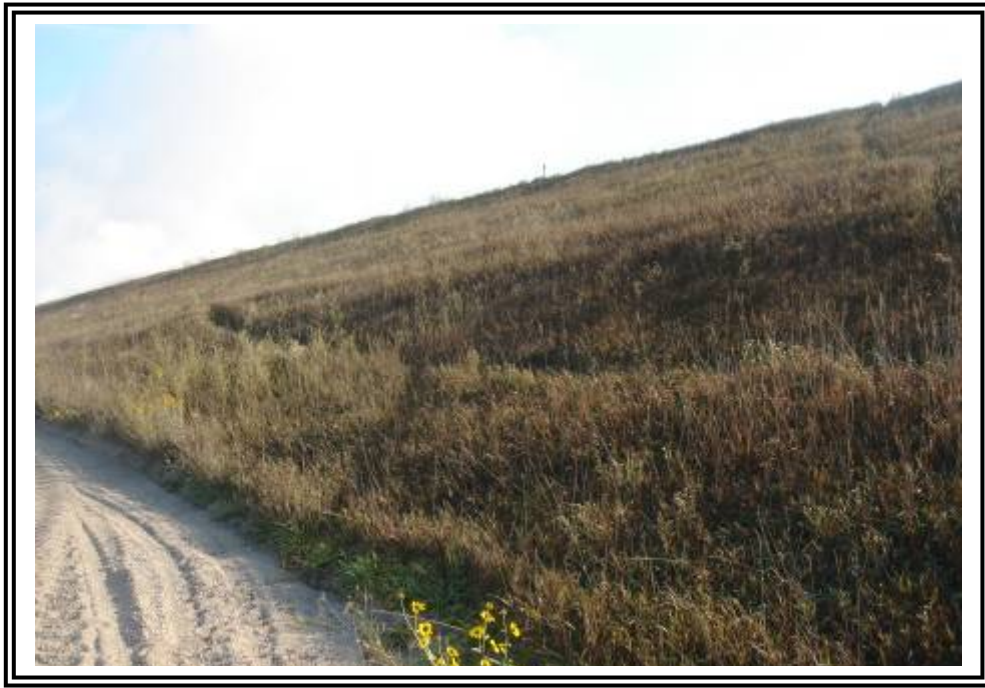
30

Downstream embankment slope of West Dam, facing north.

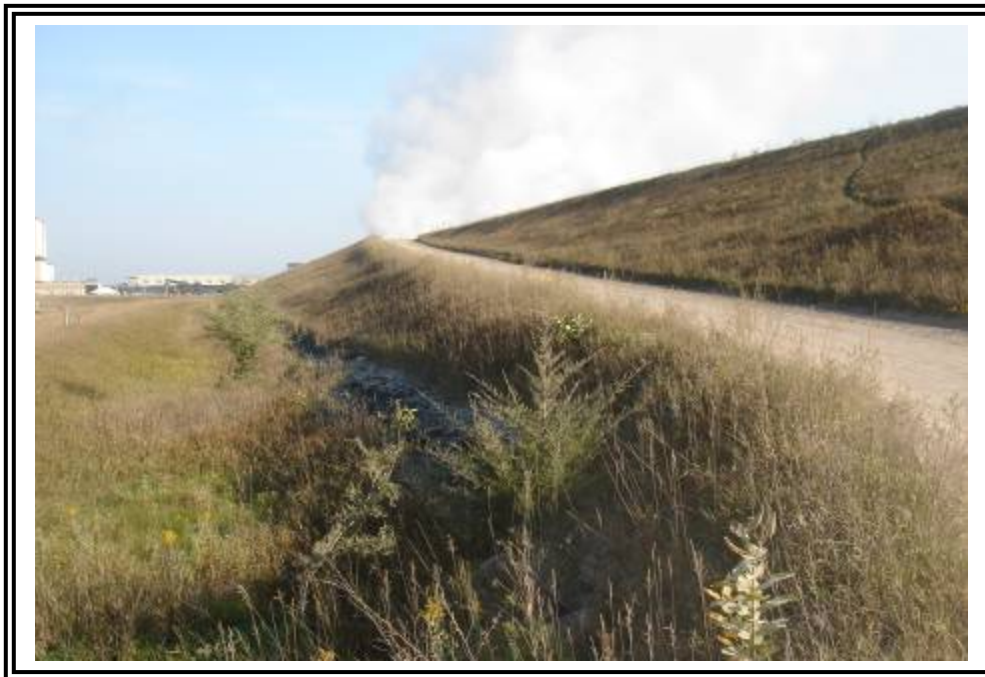
31

Downstream embankment slope of West Dam, facing north.

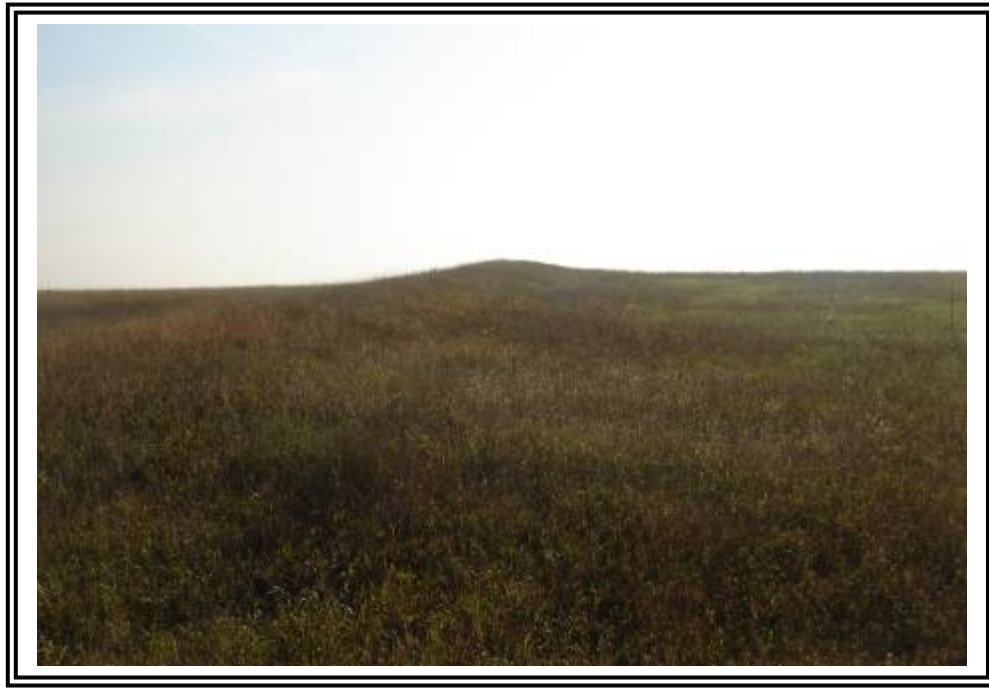
32

View across Pond 1 cap from West Dam, facing east.

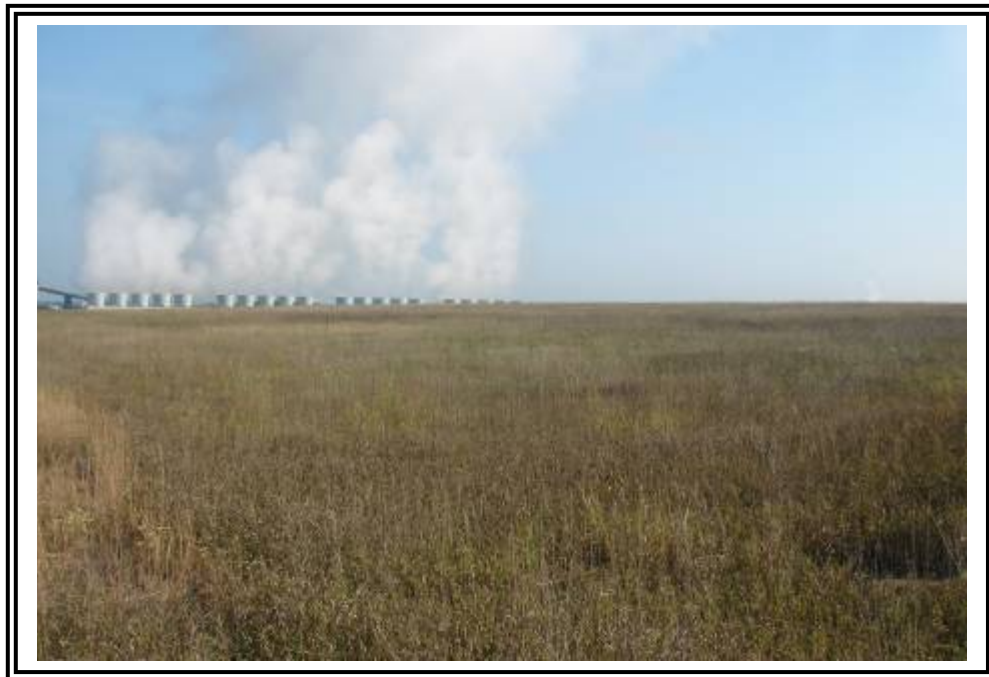
33

View across Pond 1 cap from West Dam, facing northeast.

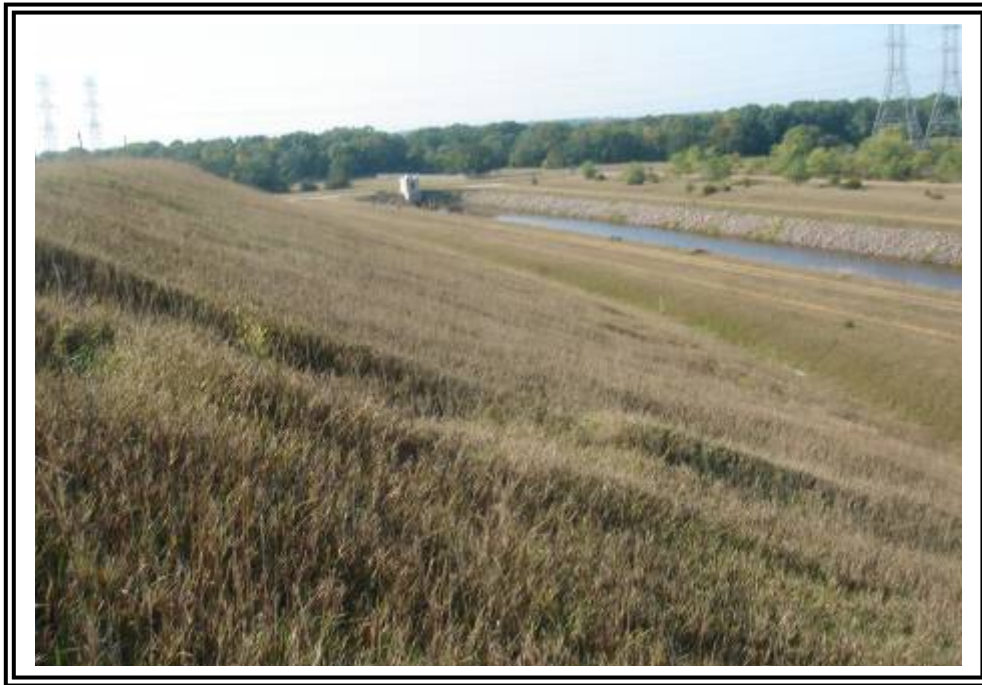
36

Downstream embankment slope of West Dam, facing south.

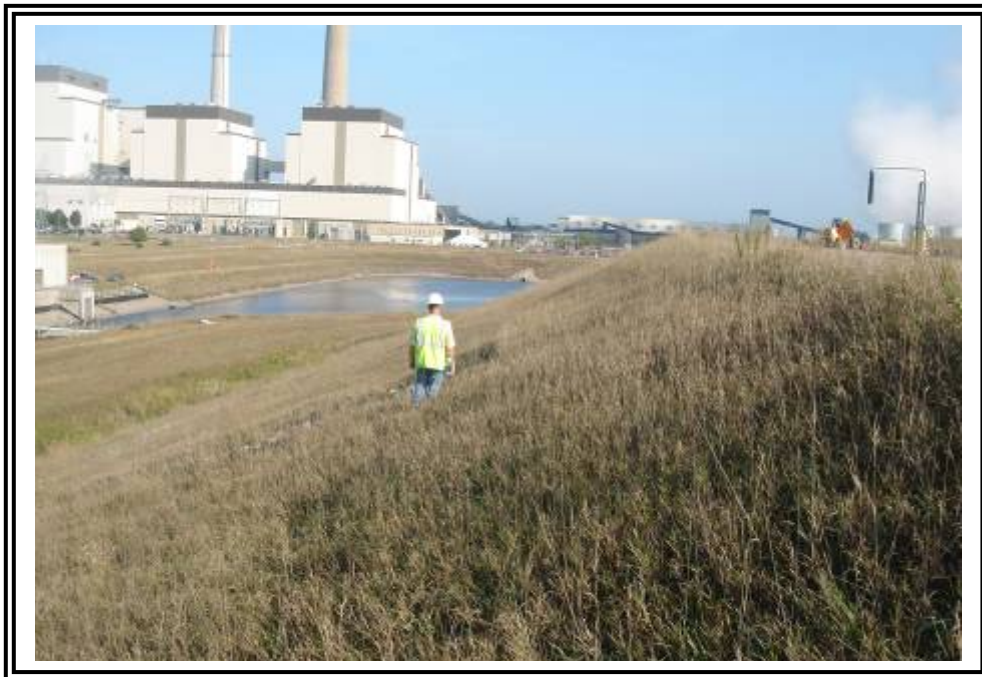
37

Downstream embankment slope of West Dam, facing north.

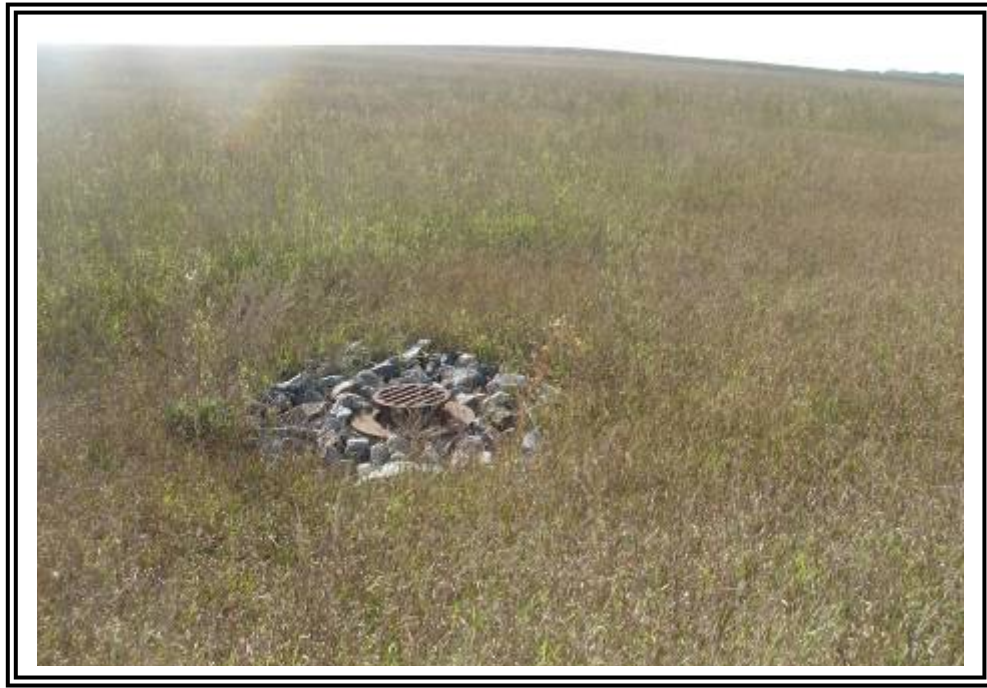
38

Drainage inlet in Pond 1 cap, looking east.

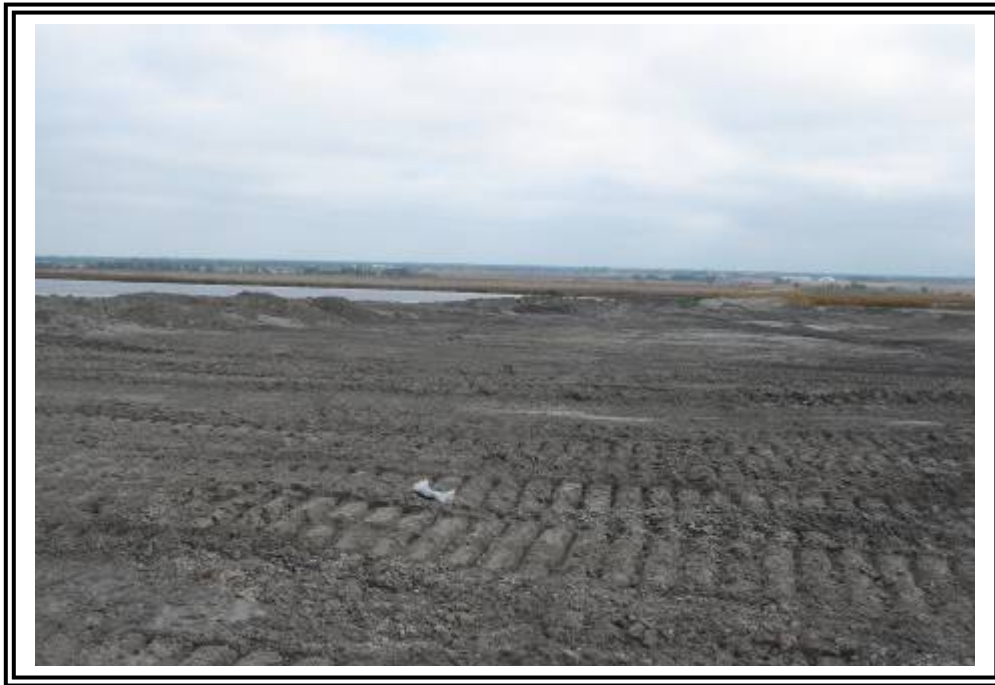
39

Pond 2 filling operations, facing northeast.

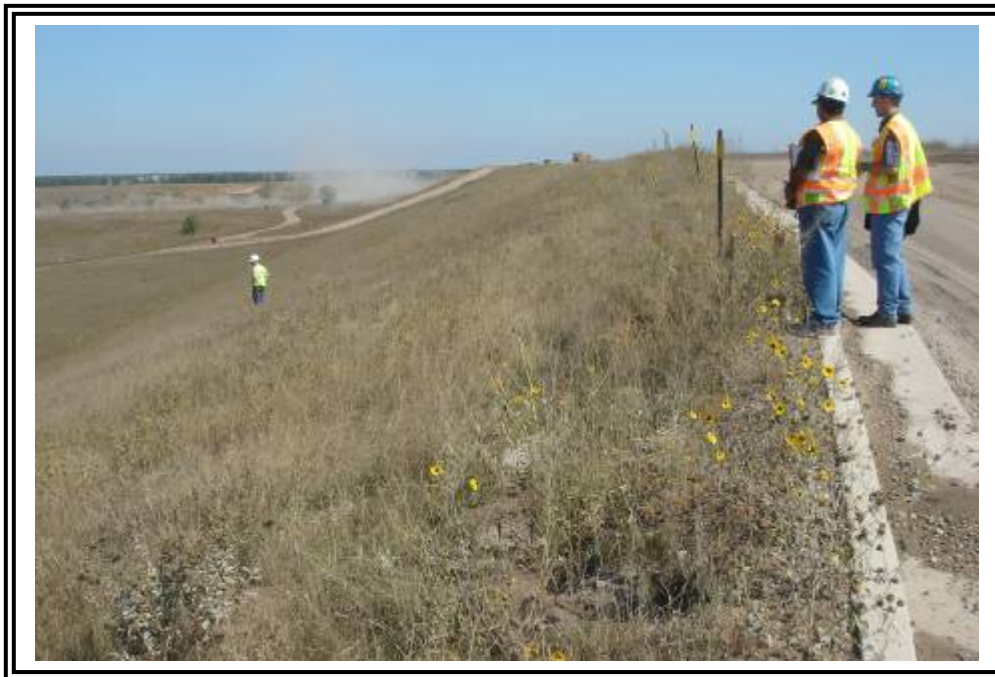
40

Downstream embankment slope of North Dam, looking east.

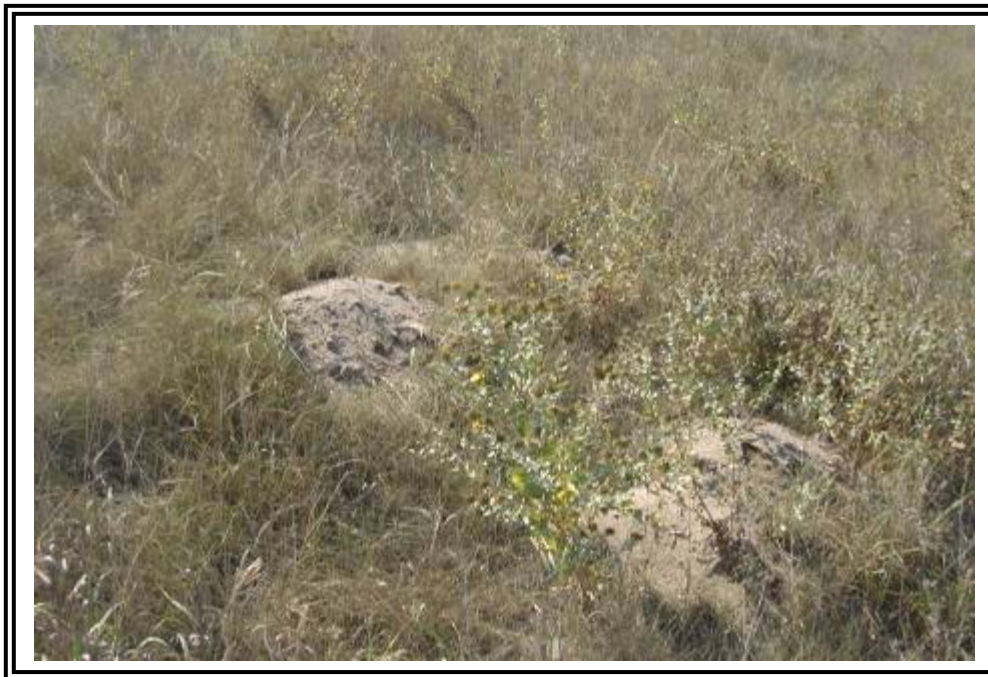
42

Animal burrows on downstream embankment of North Dam.
